CASE TITLE

Post-Crash Analysis Report

Rick August, PhD

Smart Drive Test Inc.

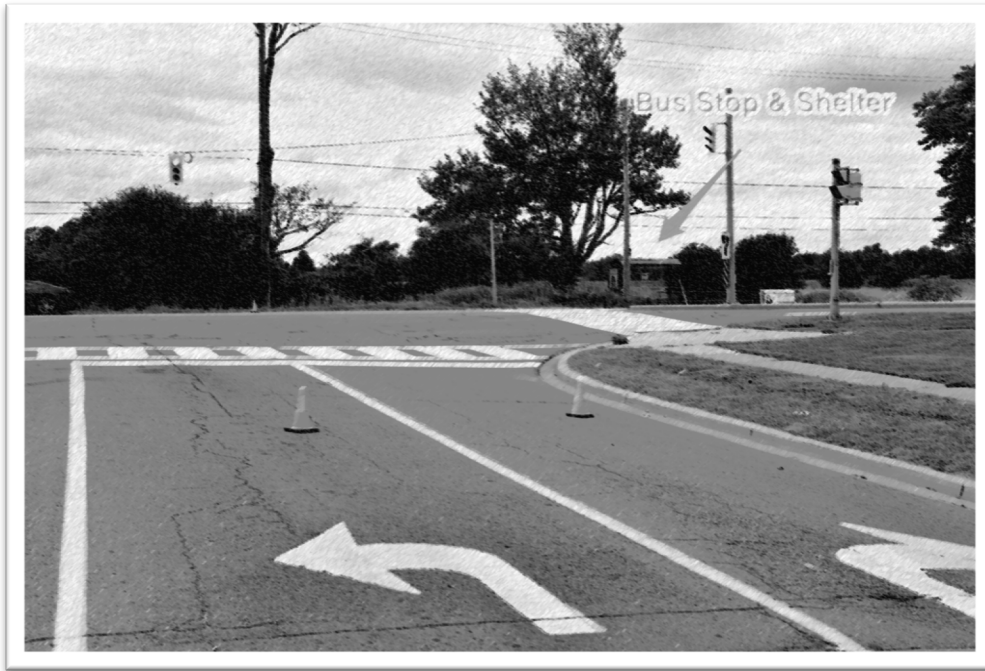
Figure 1- Image looking east-northeast from [ROAD] showing the two crosswalks and the bus stop on the intersection's outer northeast corner.³

- The "T" intersection of [ADDRESS] only had two crosswalks, as opposed to four: one running east to west on its north perimeter. The other running north-south on the intersection's east side.
- This north crosswalk only accesses the transit stop located on the northwest outer corner.
- The transit stop located there has space for transit buses to pull off the traveled portion of the road.

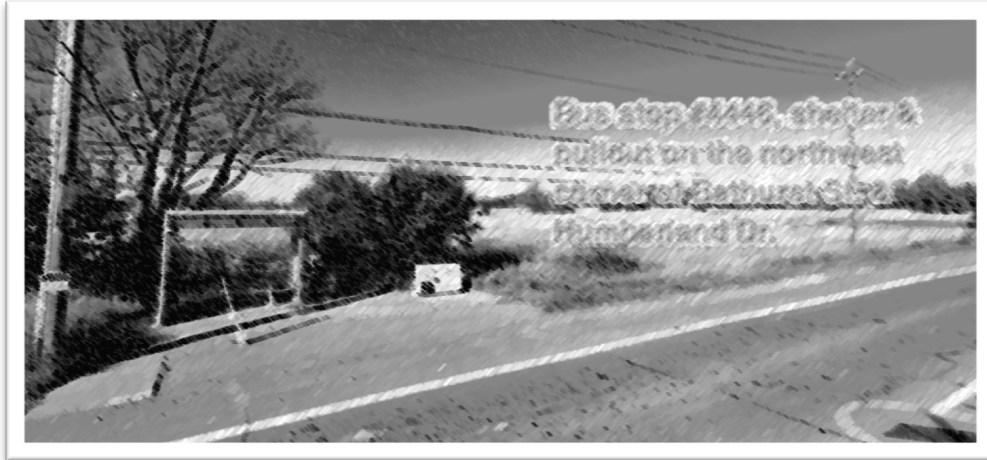
Figure 2 - Bus stop, shelter and pull out on the northwest corner of [ADDRESS].⁴

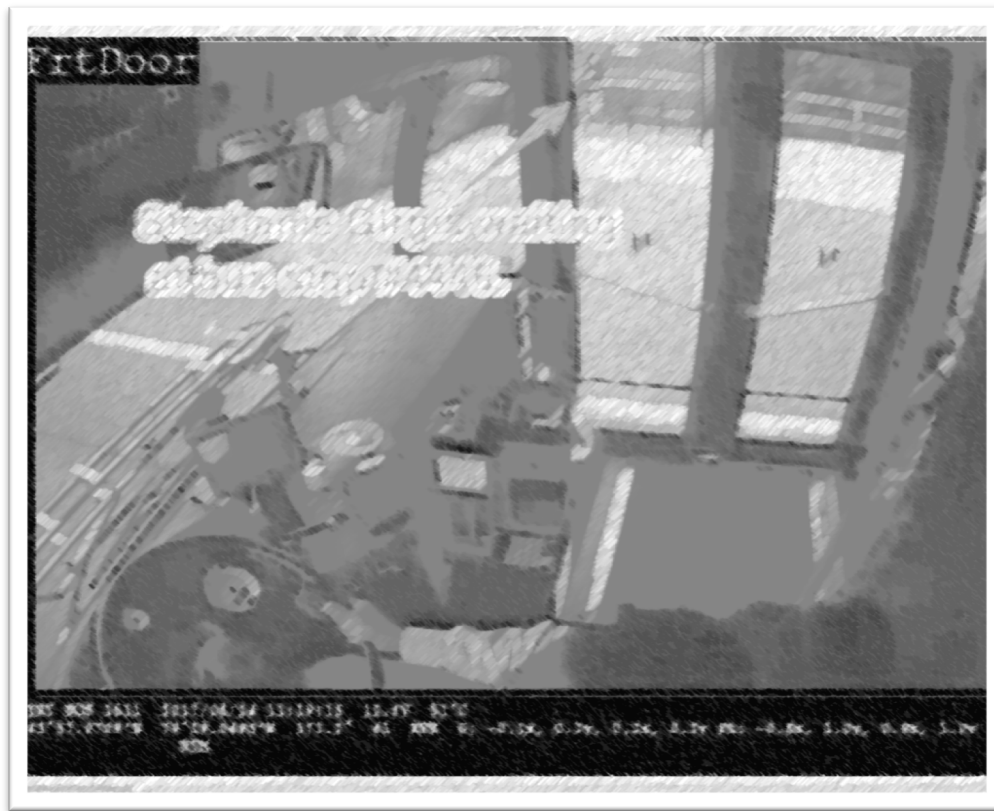
Figure 3- Screen capture of the Front Door video camera video at 00:16 that clearly shows WITNESS waiting at bus stop #[NUMBER] inside the shelter.⁹

1. adolescents,
 2. students,
 3. new immigrants,
 4. and single parents.⁷
- Being on the same run for almost eight weeks, DEFENDANT #2 should have recognized both the bus shelter with its pullout, and the potential passenger that was approaching the intersection to catch the bus.⁸

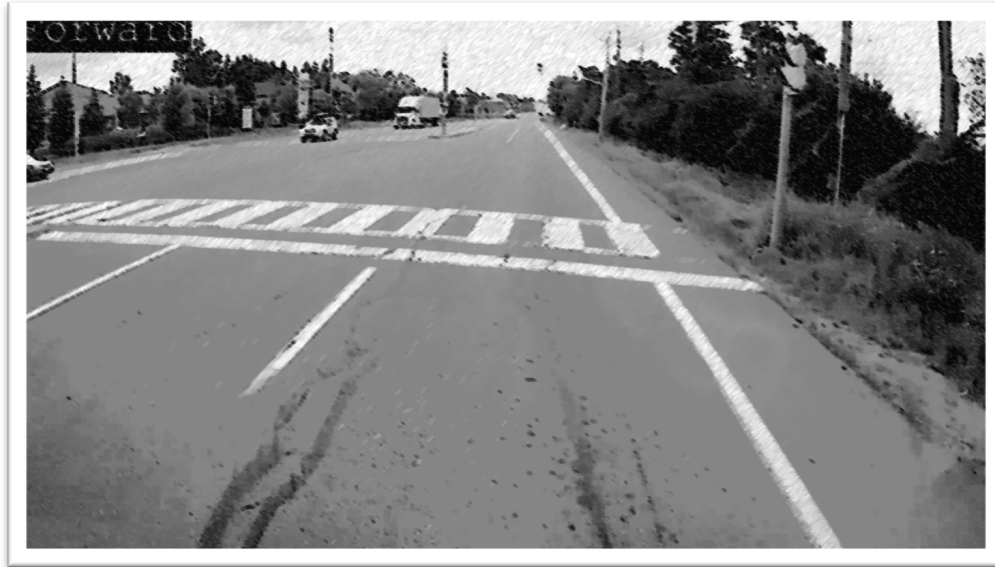
Figure 4- The view from the Forward camera at 11:19:14, the approximate time of the bus' braking.¹¹

- DEFENDANT #2 maintained at an approximate speed of 60kph until passing bus stop #[number] and realizing that a pedestrian waited there he slowed the bus through the intersection.¹⁰
- DEFENDANT #2 began to brake and slow the bus just as the front of the bus passed the bus shelter.

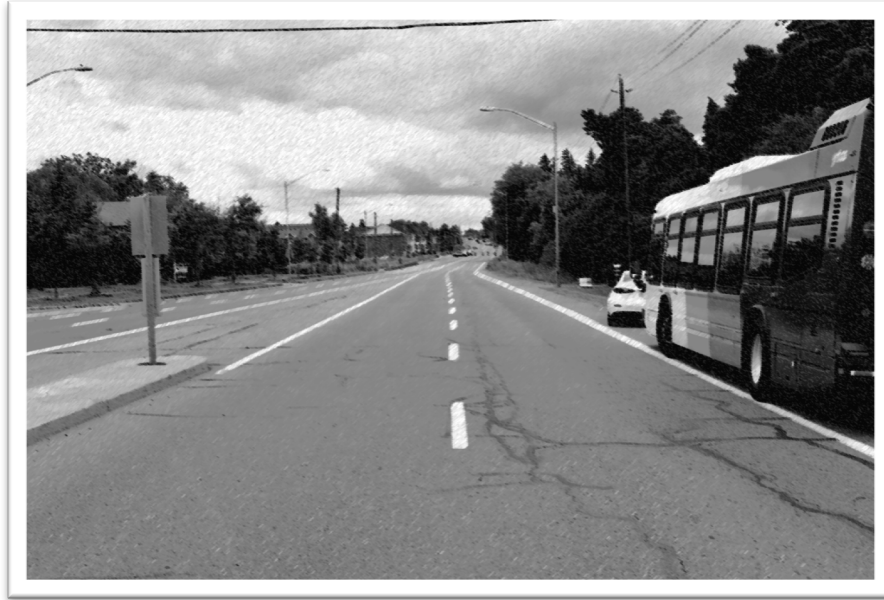
Figure 5- Image looking southbound along [ROAD] on the south side of the intersection. Here the bus is completely off the travelled portion of the road. The bus had been moved after the incident and before police began their investigation.¹²

- On the south side of the intersection, after the crash and before the police investigation, DEFENDANT #2 pulled the bus completely off the travelled portion of the road.

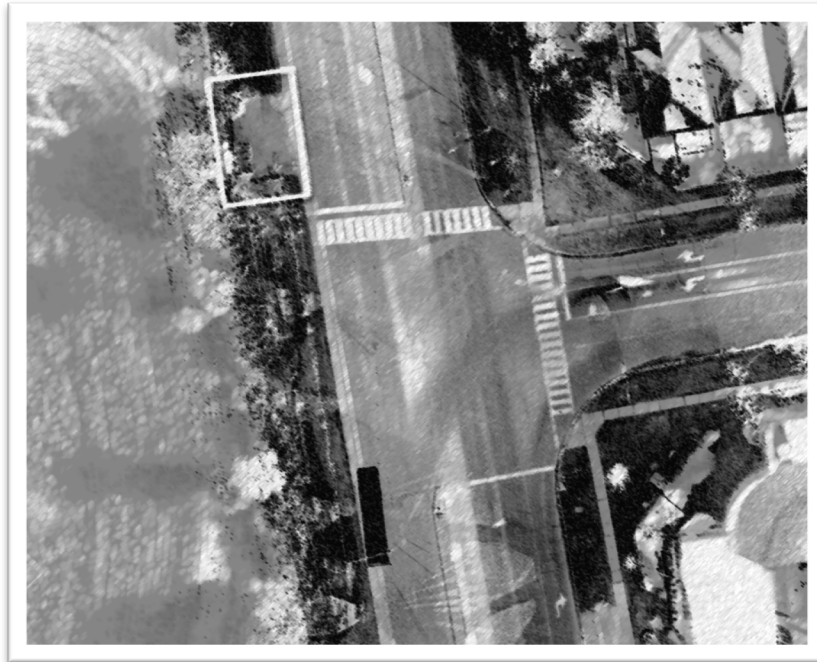
Figure 6- Image showing the location of the stopped bus. It's still in the intersection and blocking the right lane southbound. Two cars changed lanes behind the bus in the

intersection to move around it. The hazard of the cars moving into her lane was what drew DEFENDANT attention as she neared the intersection.¹³

The position of the stopped transit bus caused upstream traffic to change lanes in order to move around the bus. This changing traffic situation demanded DEFENDANT attention. She focused on the transit bus and the two other cars that changed lanes to move around the obstacle. The DEFENDANT was looking at the west side of the intersection.¹ PLAINTIFF approached from the east.

Bus drivers are not to stop in intersections owing to the high percentage of crashes that happen in this location - more than 40%. Stopping in an intersection is an unpredictable and dangerous action. This action often causes both distractions and other traffic to move around the stopped bus. In an attempt to prevent crashes, engineers and other transit authorities strategically place bus stops at a safe distance from intersections. Bus stops in high-density traffic areas often have pullouts to move the bus off the travelled portion of the road, thus increasing passenger safety. In conjunction with infrastructure, defensive driving courses move to educate bus drivers about the inherent risk of intersections and the dangers of stopping in this location.

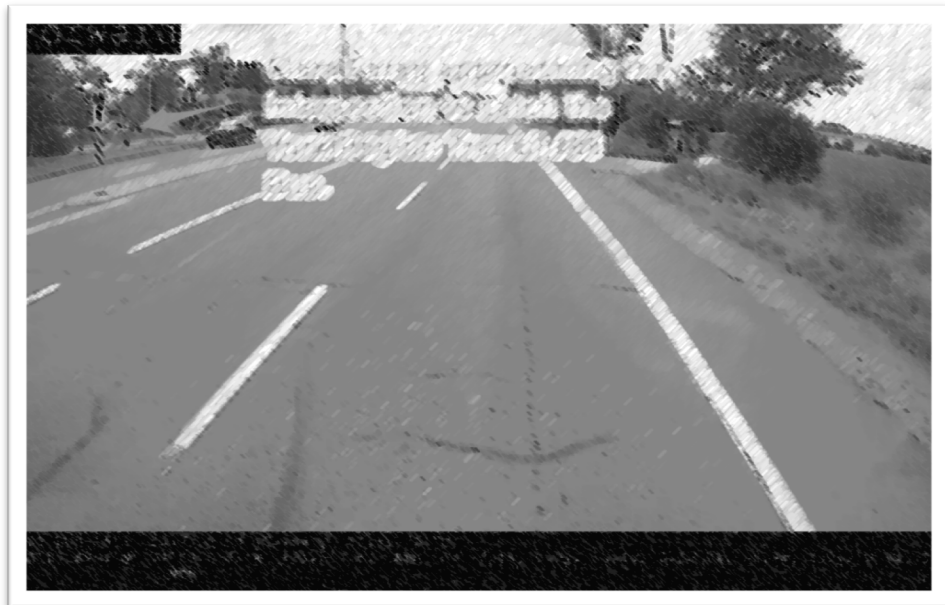
Figure 7- Screen capture of the forward video camera video at 00:15 that clearly shows PLAINTIFF approaching the intersection to catch the #[number] bus southbound.¹⁶

- PLAINTIFF was approximately 10m from the northeast corner of the intersection at the same instant that the DEFENDANT #2's bus was approximately 10m north of the bus stop.

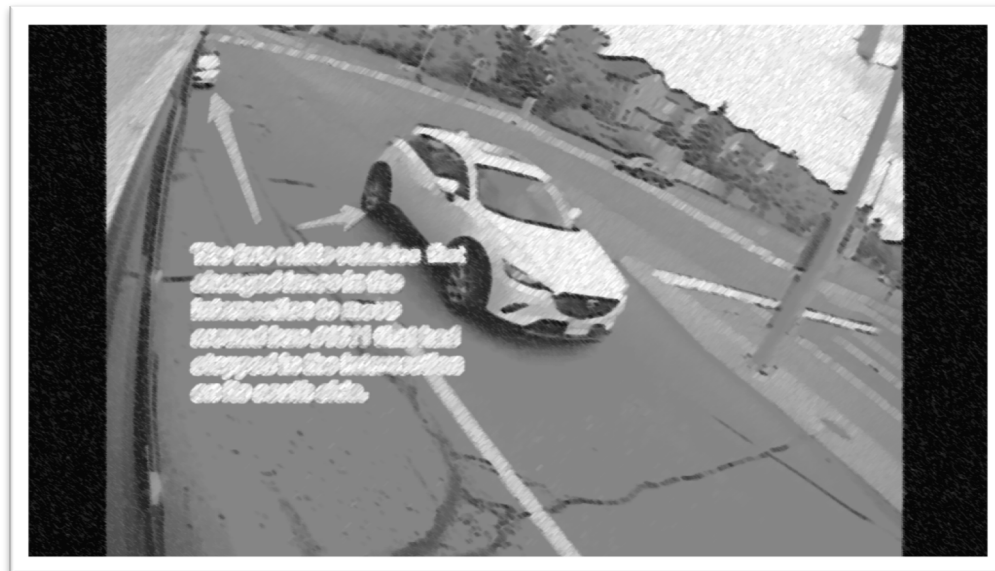
Figure 8- Two cars changed lanes behind the bus in the intersection to move around it. The hazard of the cars moving into her lane was what drew DEFENDANT attention as she neared the intersection.¹⁷

- Two white vehicles changed lanes in the intersection to pass the stopped transit bus.
- The first, a white Mazda CX 5, saw the stopped bus and fluidly changed lanes through the intersections, passing the white Honda Civic.
- The white Honda Civic failed to identify the stopped bus in time, and stopped behind it waiting for traffic to clear. The Mazda CX-5 passed and then the driver of the Honda Civic changed lanes and moved around the stopped bus.

Mazda sedan driven by the DEFENDANT approached the intersection. Her attention was forward, focused on the hazard to her right. That hazard was the cars changing lanes in the intersection to maneuver around the stopped bus.

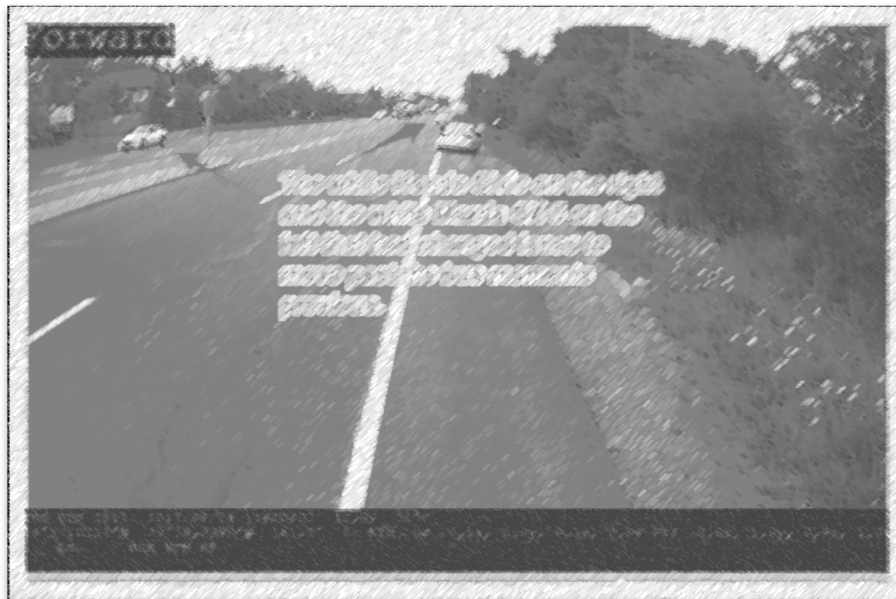
Figure 10 - Both the Mazda CX-5 and the Honda Civic stopped after the crash. The drivers were close enough to the intersection that they saw the collision. The Civic driver pulled over and stopped. The Mazda driver did a “U” turn and returned to the intersection.¹⁹
