[CASE TITLE]

Post-Crash Analysis Report

Smart Drive Test Inc.

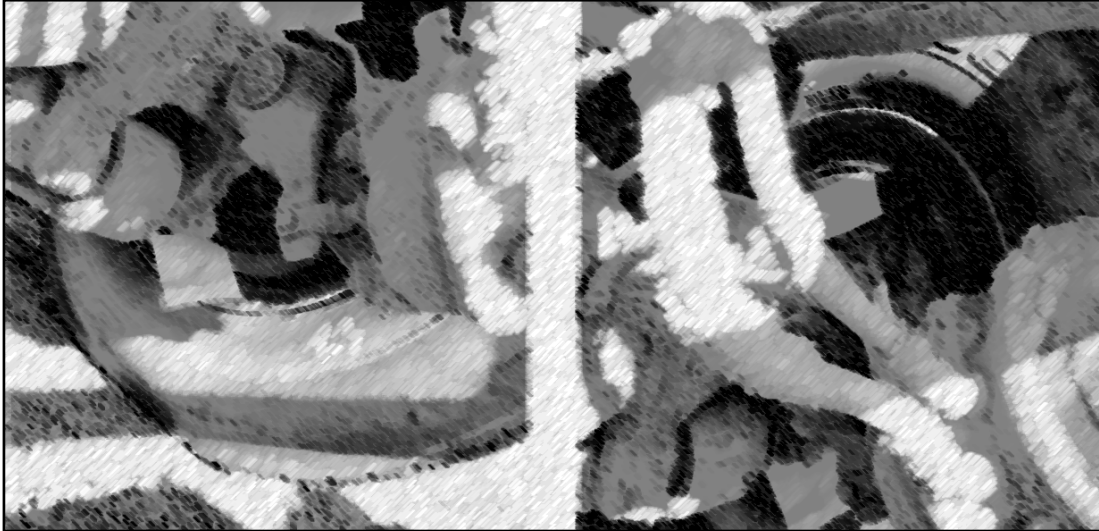
Figure 2 – with the parking brakes applied, post-crash investigators were able to place pieces of paper between the brake shoes and the drum. The rust and build-up of caked sludge on the brake and suspension components suggests that no mechanical repairs have been made to this truck for more than six months.⁶

- On three of the four rear parking brakes, the brake shoes did not come in contact with the drum. As seen in Figure 1, the difference in pushrod stroke between the service and parking brakes was:
 - Right-rear: 1 7/8"
 - Left-middle: 1 3/16"
 - Left-rear: 7/8"

Three days prior to the collision that killed [PLAINTIFF], the [REDACTED] cement truck had had its mandatory annual inspection. Of all the safety features inspected by a diesel technician during an annual inspection, brakes are at the forefront. Post-crash investigators sliding paper into the gap between the brake shoes and drum with the

parking brakes applied indicated that the truck was devoid of parking/emergency brakes. Further, the rust and buildup of sludge on the vehicle's undercarriage further substantiates that no repairs had been done to the truck within a few months, let alone three days.

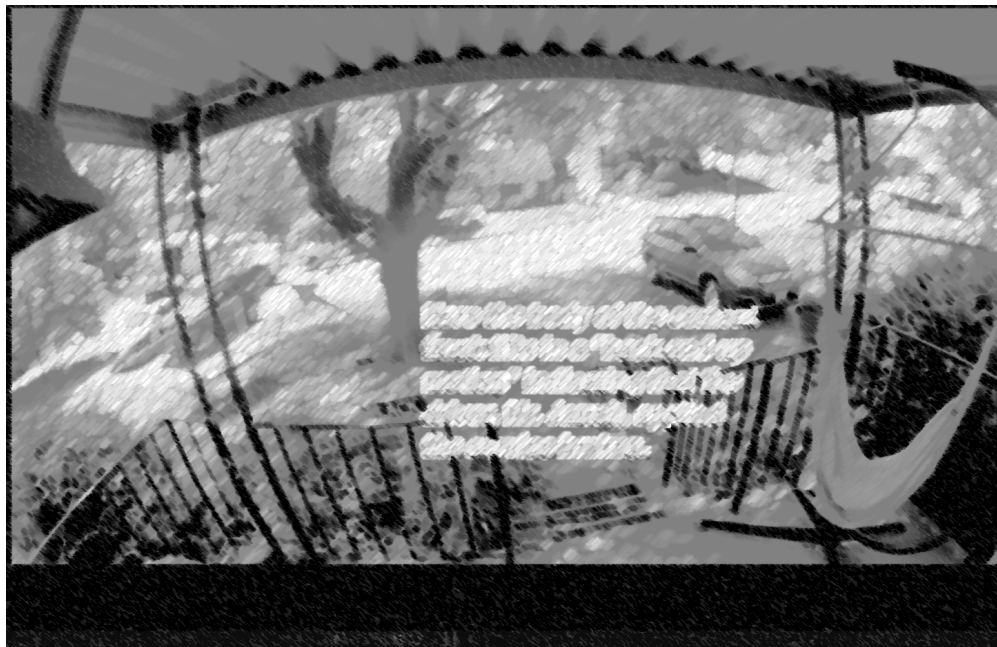
Figure 5 – At 8:12 in the video you can see the cement truck coming to a stop. The cab of the truck lifts up and back from the chassis. This motion indicates that the service brakes were applied.¹¹

- [DRIVER] stopped the runaway truck using the service brakes. In the doorbell security video, the body of the truck lifted from the front chassis, indicating that the front service brakes were working and able to bring the vehicle to a stop.¹²
- Police reported no skid marks at the site of the collision.¹³
- The truck was in the shop on [DATE] for its mandatory annual inspection of which brakes are a major component.¹⁴
- To measure service brake pushrod stroke, diesel technicians would have most likely pressure washed the underside of the truck to both determine that the brakes were in adjustment and repair any defects to the brakes and vehicle.

Although the parking brakes on the vehicle's rear axle did not work, the service brakes on the front axle worked sufficiently to drive the vehicle and stop it in traffic. This fact is evidenced by [DRIVER] bringing the runaway vehicle to stop moments after the crash.
